Contract #: 04-0120F4Cty: SF/ALA Rte: 80 PM: 13.2/13.9File #: 69.28**WELDING INSPECTION REPORT****Resident Engineer:**Pursell, Gary**Address:** 333 Burma Road**City:** Oakland, CA 94607**Report No:** WIR-003121**Date Inspected:** 15-Jun-2008**Project Name:** SAS Superstructure**OSM Arrival Time:** 2300**Prime Contractor:** American Bridge/Fluor Enterprises, a JV**OSM Departure Time:** 730**Contractor:** Zhenhua Port Machinery Company, Ltd (ZPMC), Changxing Island **Location:** Shanghai, China

New Tower Bay 1

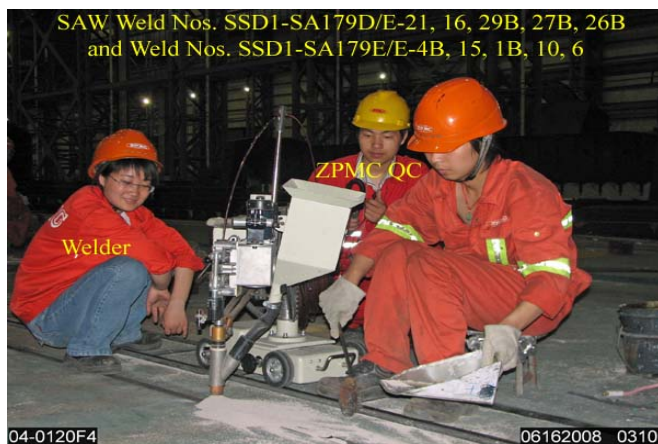
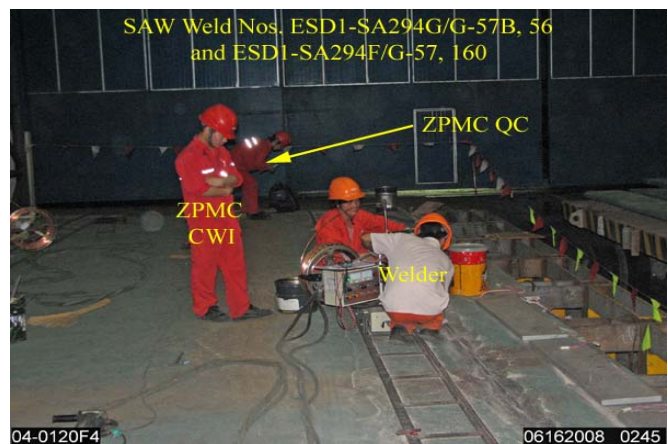
The Caltrans QA Inspector randomly observed the magnetic particle examination (MT) of the root pass on Weld Nos. SSD1-SA179D/E-21, 16, 29B, 27B, 26B and SSD1-SA179E/E-4B, 15, 1B, 10, 6 by ZPMC Nondestructive Examination (NDE) technician, Bu Tin Yui. The ten weld numbers are actually on one weld joint. The "A" welds are complete joint penetration (CJP) and the remaining welds are partial joint penetration (PJP). They alternate CJP/PJP along the joint. After acceptance of MT by ZPMC, the QA Inspector observed the application of preheat using resistance heaters. Later, the machine Submerged Arc Welding (SAW) of fill passes on these welds was observed. They are part of Skin Plate Face "C". The welding was performed in the flat groove (1G) welding position by two welding operators; Xu Yan (I. D. No. 052917) and Xi Xiu shui (I. D. 040489). Welding Procedure Specification (WPS) WPS-B-T-2221-B-U3c-S was used for the CJP portion of the weld and WPS-B-T-2312-B-P3-S was used for the PJP portion. Certified Welding Inspector (CWI), Liu Hua jie (CWI No. 07120741), was present during the welding, as was ABF QA Inspector, Wei Jian Bo. The Caltrans QA Inspector verified the qualifications of the welding operators, and that the electrode/flux classification, diameter of electrode, amperage, voltage, travel speed, and preheat/interpass temperatures were within the specified ranges on the applicable WPS.

The Caltrans QA Inspector randomly observed the machine Submerged Arc Welding (SAW) of fill passes on Weld Nos. ESD1-SA294G/G-57B, 56 and ESD1-SA294F/G-157, 160, Skin Plate Face "C". The four weld numbers are actually on one weld joint. The "A" welds are CJP and the remaining welds are PJP. They alternate CJP/PJP along the joint. The welding operator was Sun Bing fa (I. D. No. 062046). Two Welding Procedure Specifications (WPS) were also being used. WPS-B-T-2221-B-U3c-S was used for the CJP portion of the weld and WPS-B-T-2321-B-P3-S was used for the PJP. Certified Welding Inspector (CWI), An Qing Xiang (CWI No. 07120651), was present during the welding, as was ABF QA Inspector, Wang Cheng jun. The Caltrans QA Inspector verified the qualifications of the welding operator, and that the electrode/flux classification, diameter of electrode, amperage, voltage, travel speed, and preheat/interpass temperatures were within the specified ranges on the applicable WPS. .
